Upper Big Branch

The April 5, 2010, explosion: a failure
of basic coal mine safety practices

Report to the Governor

Governor's Independent Investigation Panel

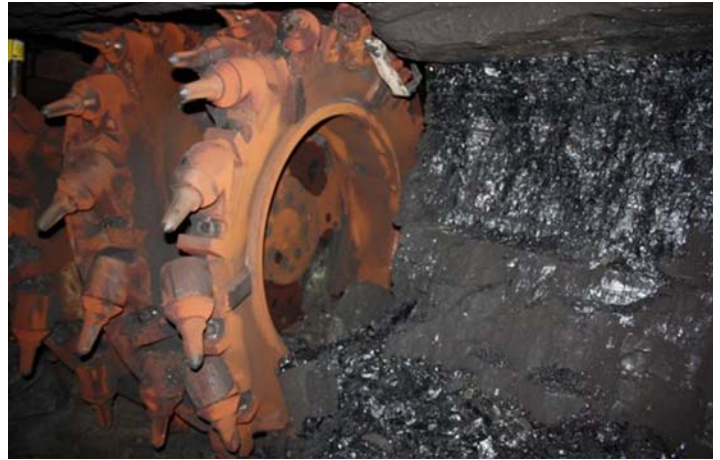
Shearer drum cutting out

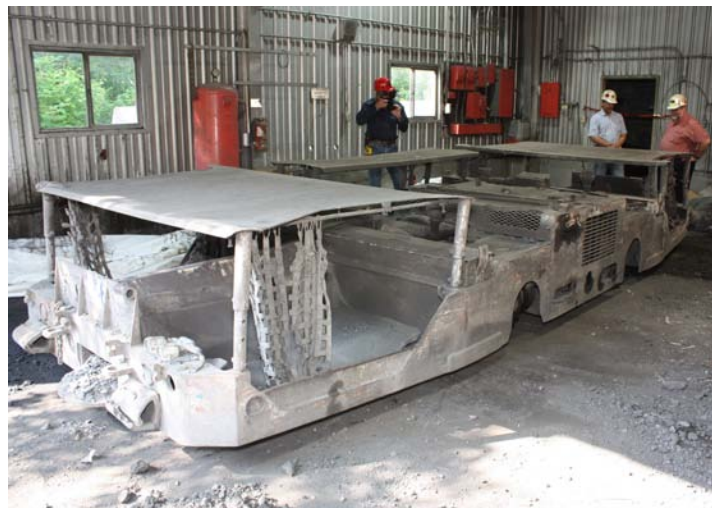
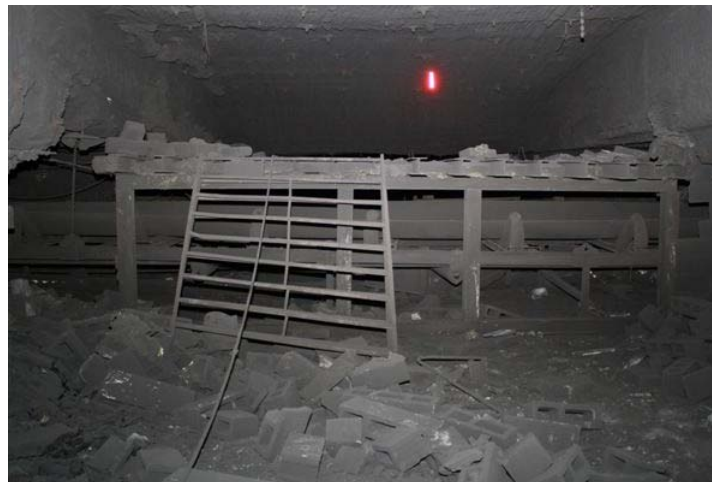
Above, the mantrip in which the Tailgate 22 crew was riding; below, the remains of a cinderblock wall gives an indication of the force of the explosion.

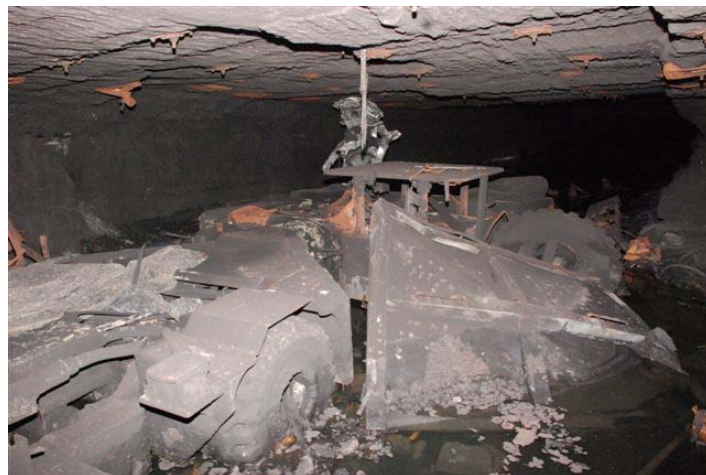
A scoop located on the Headgate 22 section after the April 5 explosion

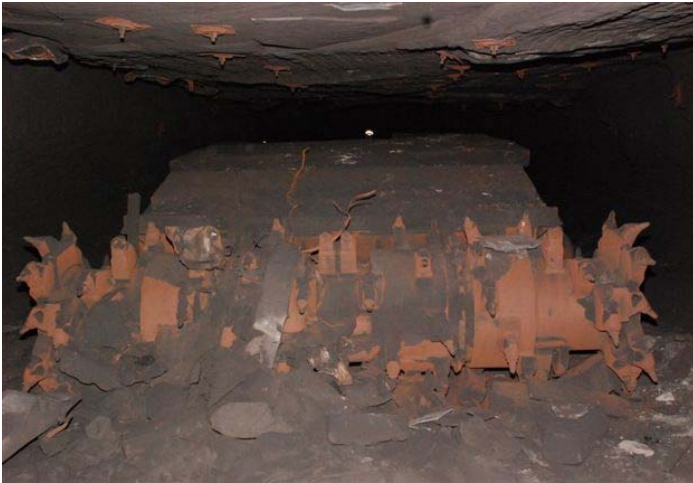
A continuous miner inside the Upper Big Branch mine after the April 5 explosion

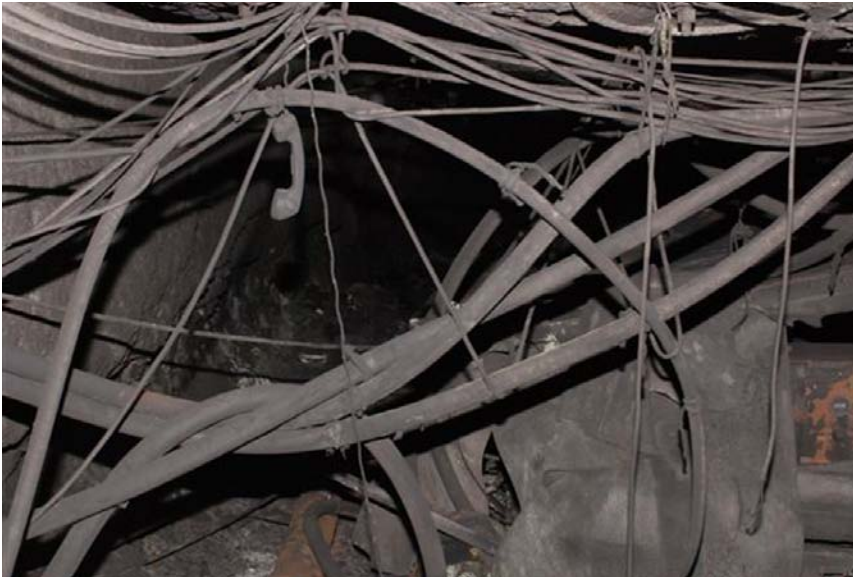
Some of the damage in the UBB mine

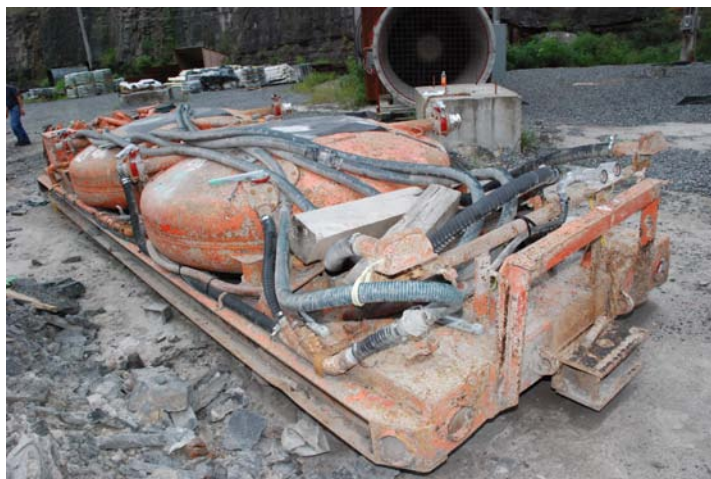
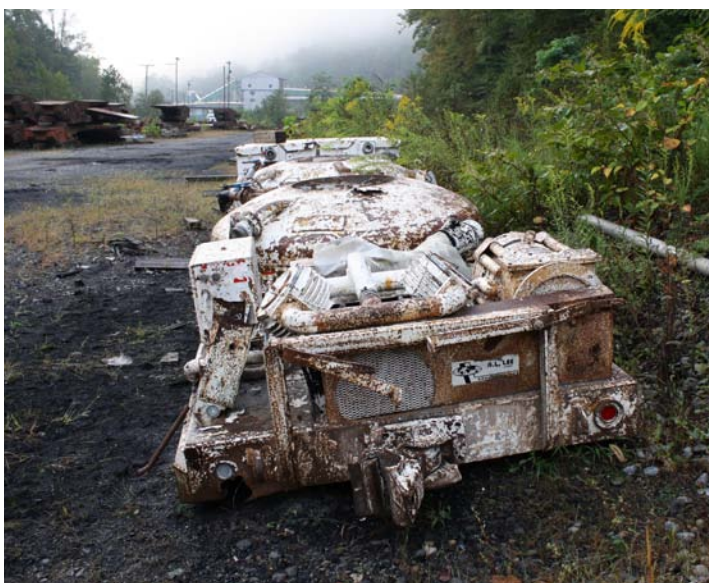
The handwritten notes tell a frustrating story of days in which rock dust couldn’t be applied because the

UBB’s orange pod duster, above, and white rock duster, below

miners ran out of dust, because the men had no motor to run the duster and, most often, because the equipment failed.

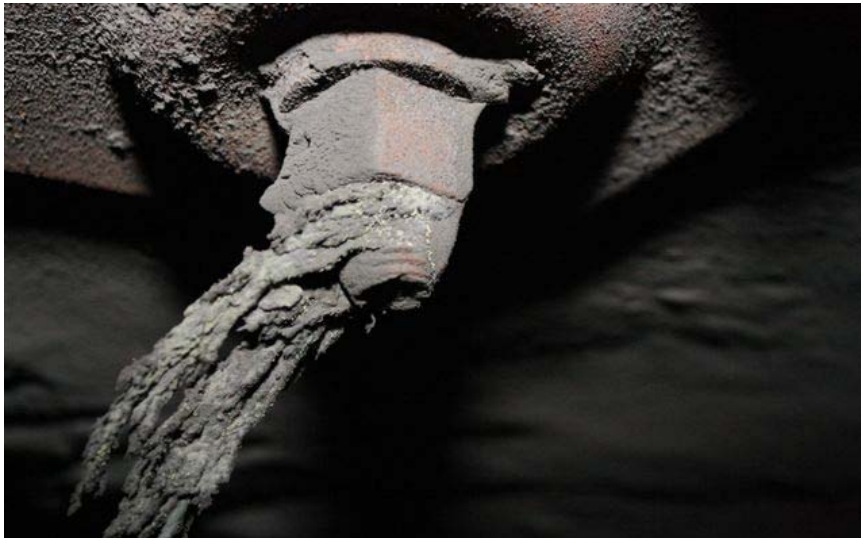
Even at this distance from the point of ignition, the force was great enough to blow two metal canopies

Evidence of the force of the explosion was left in the mine.

off of the section mantrip and hurl them for hundreds of feet in opposite directions. The power of this force suggests an explosion that gained strength and size as it traveled from the longwall tailgate, fueled by coal dust along the way. Analysis of the dust samples taken from Headgate 22 after the explosion also offers evidence that the company was not in compliance with the required rock dusting standards on this section. This inadequate rock dusting allowed coal dust to provide fuel for the explosion to continue to gain force as it traveled in and out of this section of the mine. (see Soot and Coking Map)
